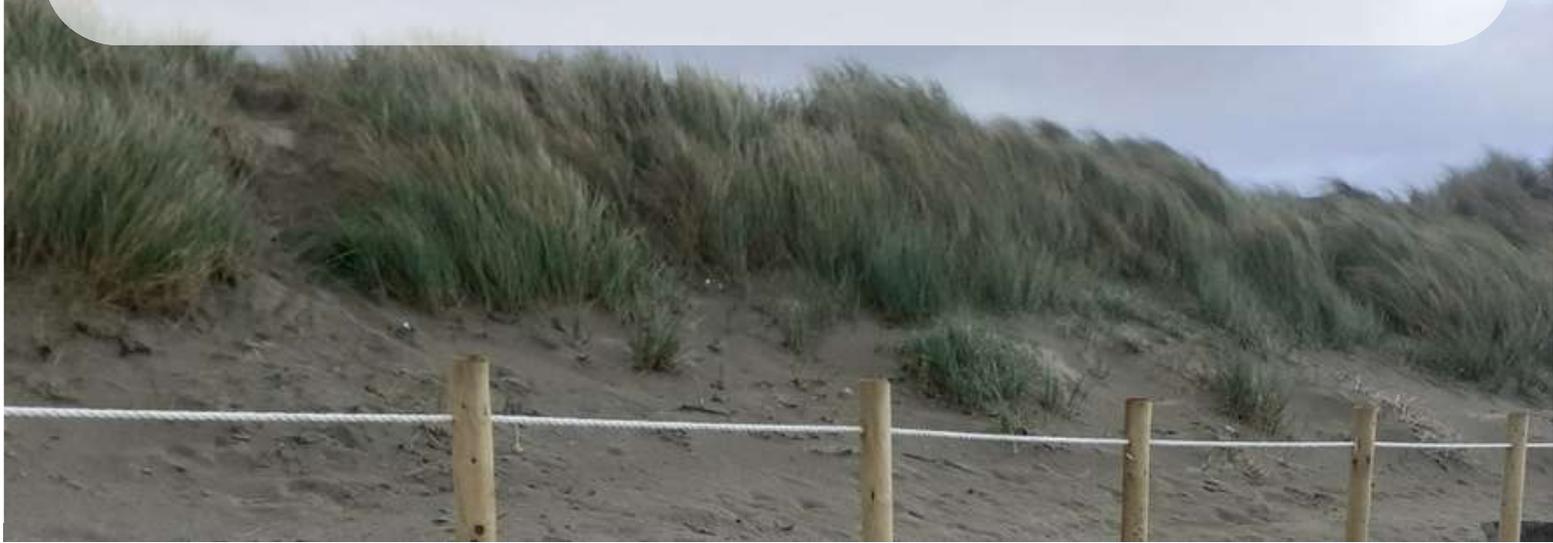
1 Sand dunes eroded by public footfall with all front edge plant species eliminated. Rear marram dunes beginning to collapse into tide.

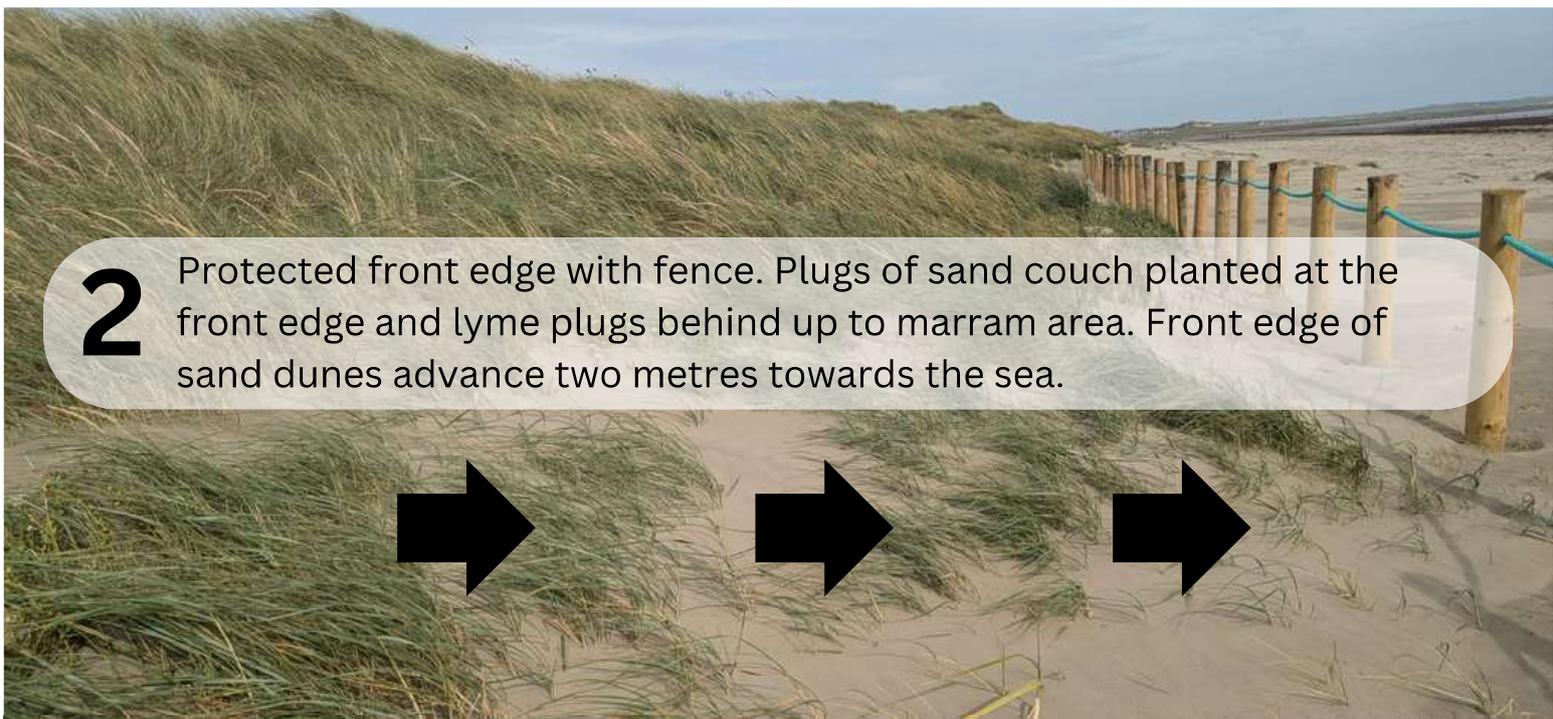
2 Protected front edge with fence. Plugs of sand couch planted at the front edge and lyme plugs behind up to marram area. Front edge of sand dunes advance two metres towards the sea.

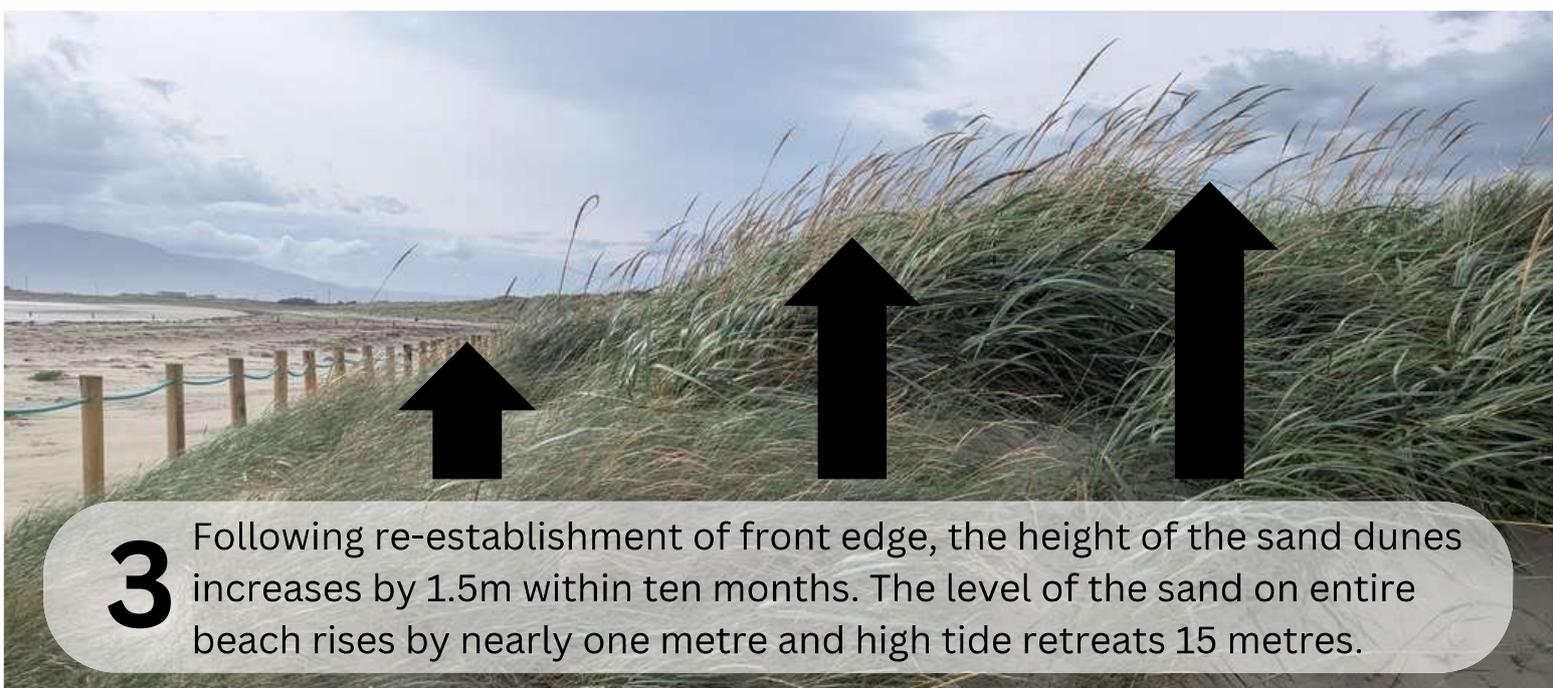
3 Following re-establishment of front edge, the height of the sand dunes increases by 1.5m within ten months. The level of the sand on entire beach rises by nearly one metre and high tide retreats 15 metres.
