# Lough Money to Myra Road

(Part of Section 1 of Lecale Way)

Report of issues September 2020

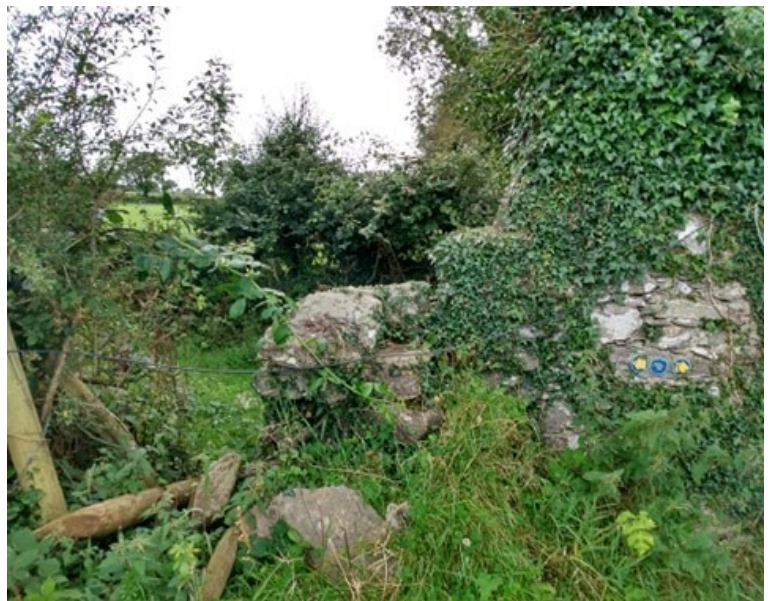
### 3 – Stile in disrepair and hazardous telephone line

At the point where the path leaves the lane to cross the field the stile is partially broken and dangerous to use. On the other side of the stile there is a telephone line down which acts as a trip hazard.

Photo 1 — Issue 3. The telephone line is lying adjacent to the stile in the foreground. The use of the stile is hampered by the broken down fence also in the foreground.

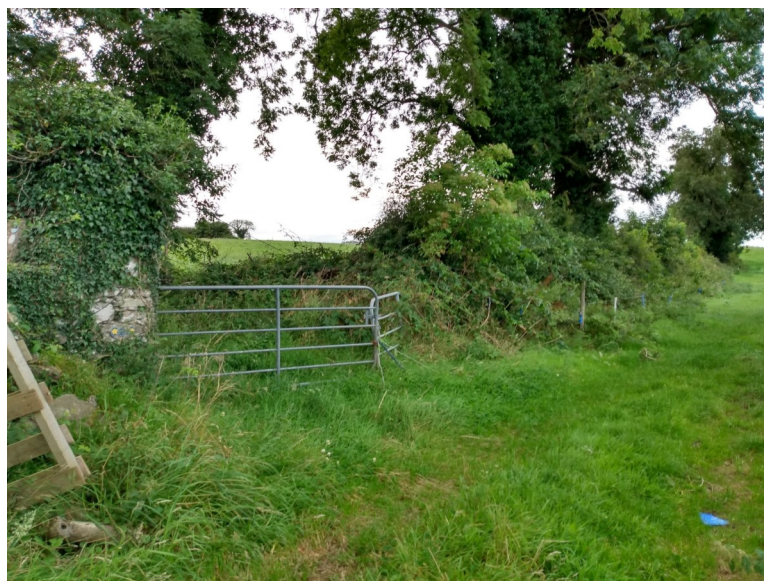
### 4 – Presence of agricultural electric fencing

Around the field which the pathway crosses there is an agricultural electric fence. This is likely to deter use of the path.

Photo 2 — Issue 4. On various occasions the electric fence has been found to be blocking access to the field. This requires walkers to take it down, climb over or duck under it.

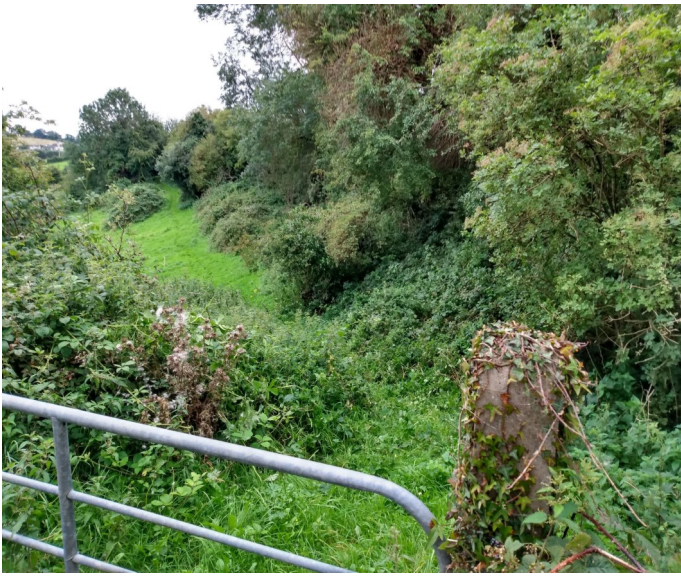
This particular section has notably more vegetation growth that the preceding section to Roneystown. This is in part due to a lack of use which has been encouraged by diversions in recent years. The vegetation causing issues also includes fallen boughs on trees. These areas are denoted on the map by a number 1.

Photo 3 — Issue 5 and an example of Issue 1.

As the field path joins onto the Strangford Road the path to the stile is overgrown. There are two sections of heras fencing placed deliberately in the corner to stop use of this section. This issue has been in situ for a number of years when the section of off-road path from Strangford Road to Myra Road was diverted. The issue is circumvented by the presence of an agricultural gate adjacent. However, use of this gate does leave the user liable for damages if they were to forget to close it correctly.

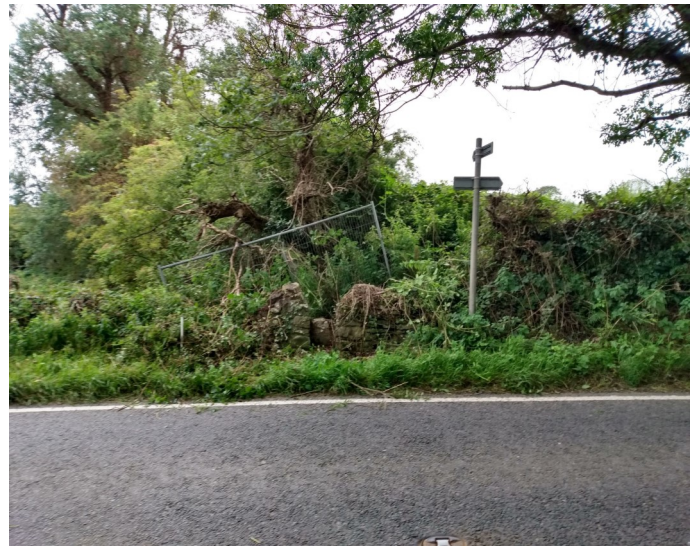
Photo 4 — Issue 5. Lecale Way signage on right hand side adjacent to the stile which walkers should be using.

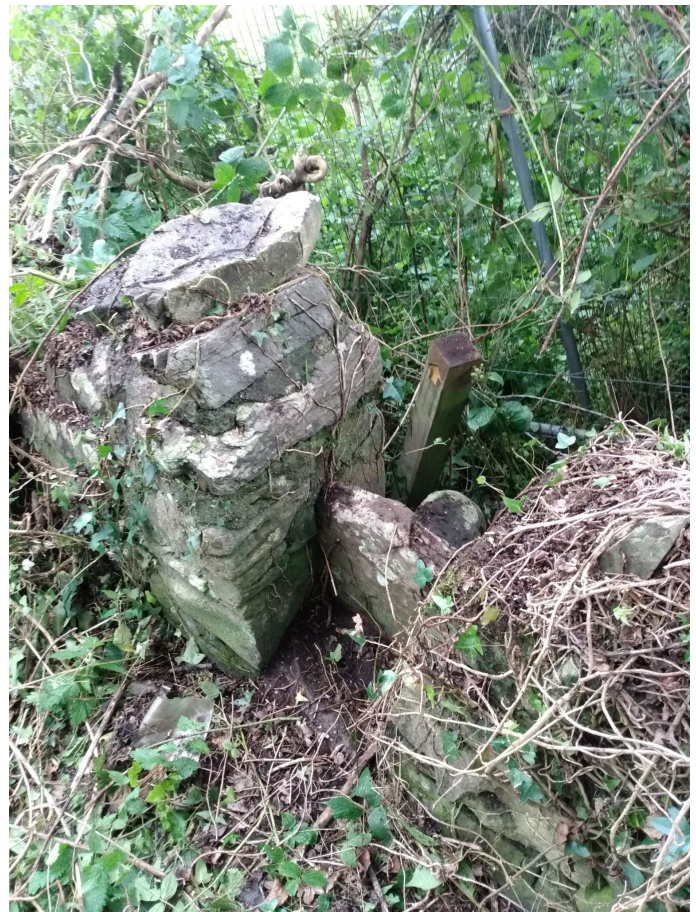
Photo 5 — Issue 5 as seen from above. Lecale Way marker post can be seen clearly. Heras fencing has been placed against the wall stopping use.

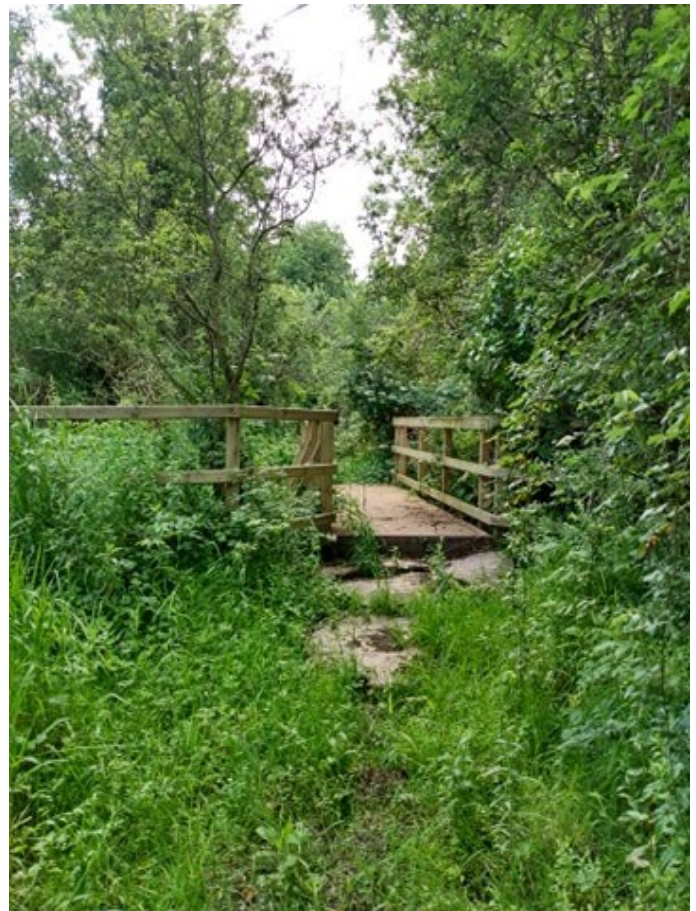
Around the new footbridge across the River Slaney the ground is sodden at all times. The western section can be crossed with some trepidation. The eastern section is more problematic. The remains of the old stone bridge have been left in situ and the surface of the path has not been returned to its original state. As you walk towards the Myra Road there is an excavated trench which floods and the right hand side of the path is formed of a raised bank which is uneven.

Photo 6 — Issue 7. The area immediately in the foreground is flooded and is an excavation trench. The walkable path is on the left hand side of the photo. Remnants of old bridge can be seen in front of the footbridge.

The remedial works for this particular issue should in the first instance to construct two sheughs on both sides of the bridge to allow the water to freely drain away. In addition the bridge surface should be extended to create a raised boardwalk on both sides of the bridge.

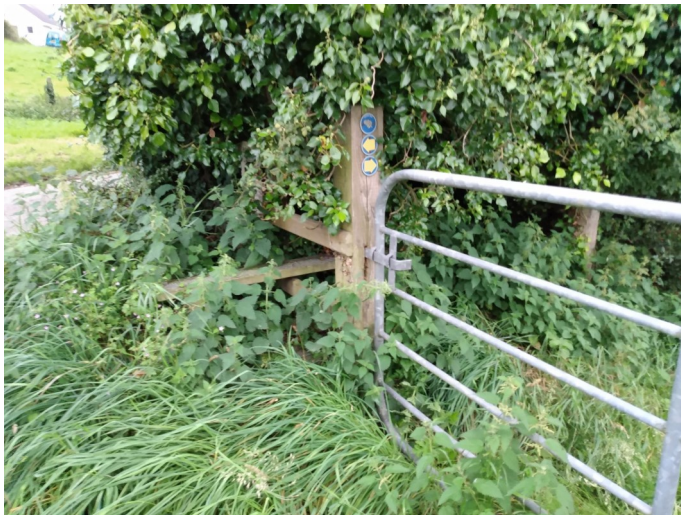
Photo 7 — Issue 8 overgrown stile and example of Issue 1.

The stile at the Myra Road is overgrown which means that walkers must use the gate.
